# TOWLINE CARE AND SHIP, PORT AND TUG CREW SAFETY

## Part 1

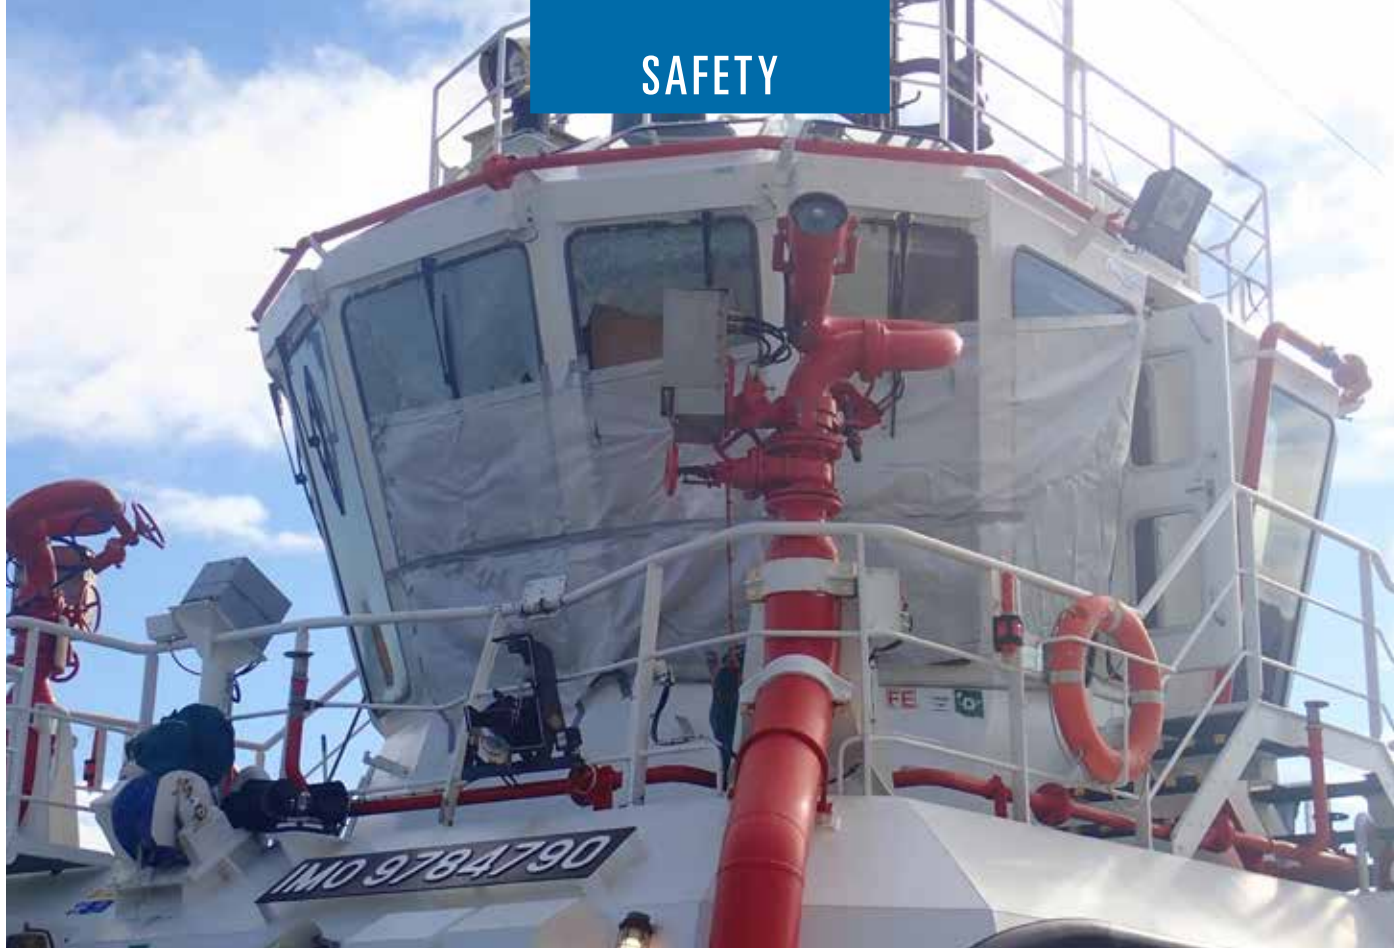
1. In December 2021, while assisting the ship Anna into the port of La Coruña, the polyester towline of the tug Ibaizábal Doce parted and hit the front of the wheelhouse [2] with extreme force. As it recoiled, the broken rope broke the windows of the tug's wheelhouse, striking the captain in command. The broken line also injured the chief engineer and the sailor. The tug is a 24-metre-long, 65-tonne bollard pull ASD tug. It made fast to the stern of the incoming ship Anna. The conditions were far from optimal: NW wind force 5 Beaufort, north-westerly swell around 3 metres high; average period 9-10 seconds. Wind and swell came from astern and on starboard quarter. Due to the rough seas, tug and ship were pitching and heaving, but not simultaneously. A few minutes after the tug had made fast, the main towline broke due to shock loading. As no damage of the deck equipment of the attended ship occurred due to the high load in the towing line, it has been as-

Tug Ibaizábel Doce with broken windows covered by plastic (courtesy Comisión Permanente de Investigación de Accidentes e Incidentes Marítimos, Madrid).
